# FEASIBILITY STUDY REPORT

## South Branch Wild Rice River Restoration & Sediment Reduction

Wild Rice  
Watershed  
District

May 6, 2020

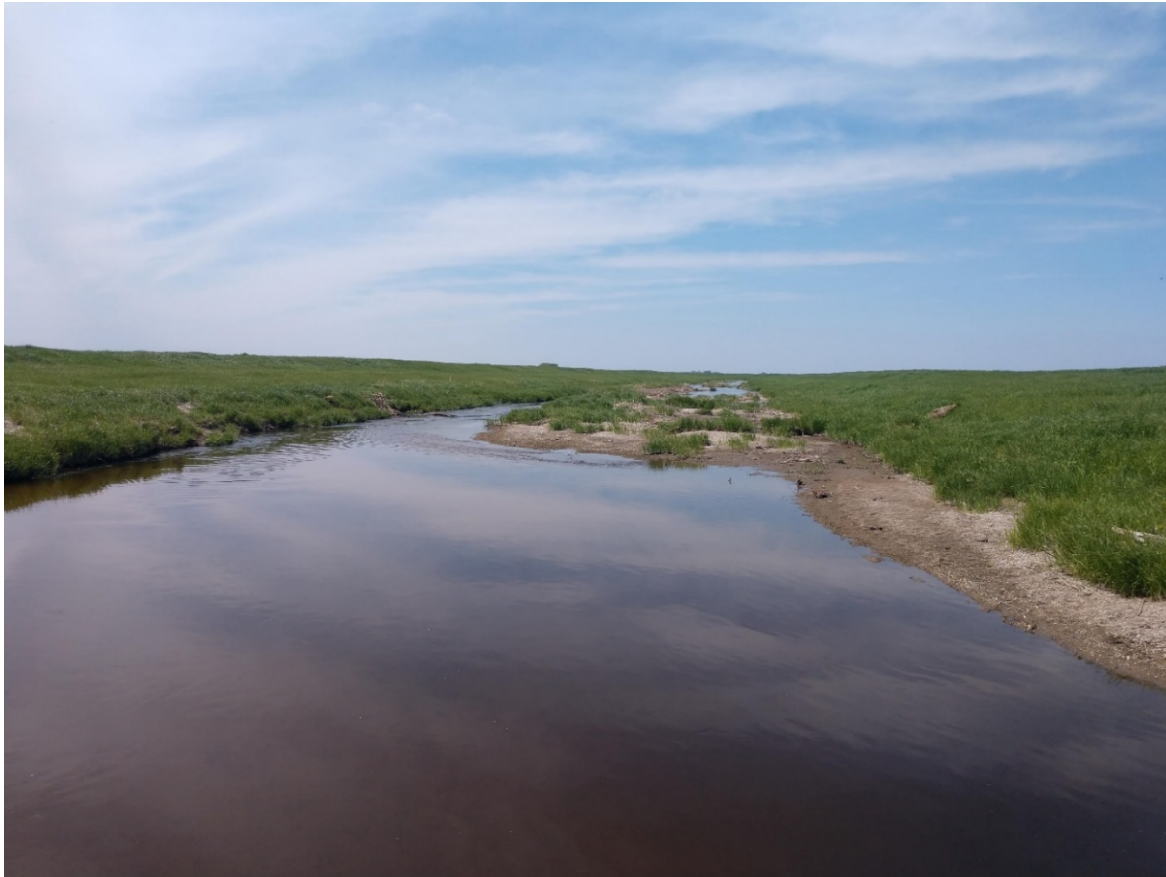
*Image 1 – Sedimentation DS of Low Water Crossing in Lake Plain Reach (Sec. 36 Winchester Twp.)*

The Lake Plain Reach is experiencing aggradation, most apparent downstream of the low water crossing. Relatively large size material is being eroded from the Beach Ridge and making its way to the Lake Plain where the river no longer has the stream power to transport the larger material. This material is settling out in the straightened channel as demonstrated in **Image 1**. Cross-sectional survey data confirms that since 2006, the straightened channel is scouring on one side and depositing the material on the other side as shown in **Image 2**. Natural meanders are forming and were visible during the site visit as shown in **Image 3**.

Cross-sectional survey data collected in the Lake Plain Reach was used to compare existing channel geometry to the USACE "as-built" geometry. In general, the channel bottom profiles are similar. However, the thalweg of the channel downstream of MN Highway 9 appears to be mildly degraded when compared to the USACE "as-builts". This apparent degradation is due to the river's attempt to re-meander within the bottom of the USACE constructed channel. Therefore, the channel bottom elevation is not consistent across the width of the originally constructed bottom. Portions of the cross section have experienced significant deposition of material. **Images 1 – 3** illustrate this geomorphic process.

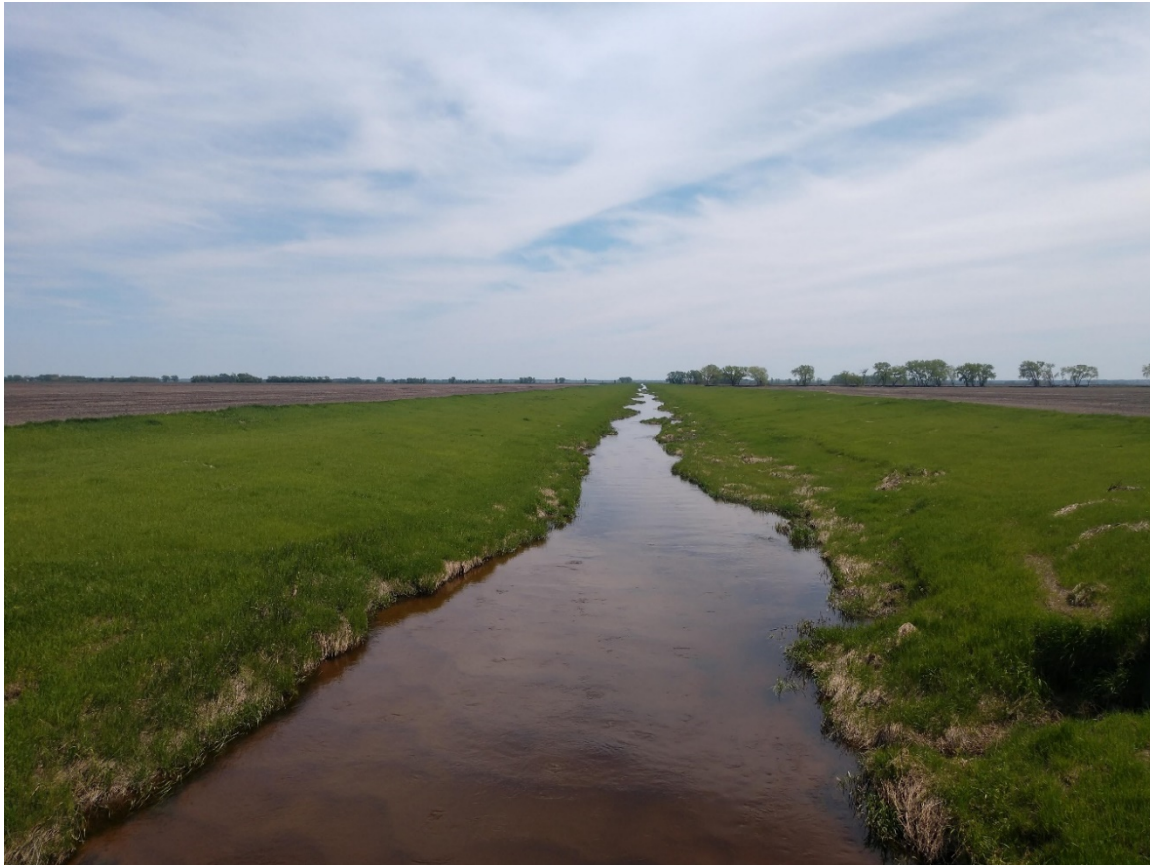
Image 3 – Natural meanders forming in Lake Plain upstream of Norman County Road 138

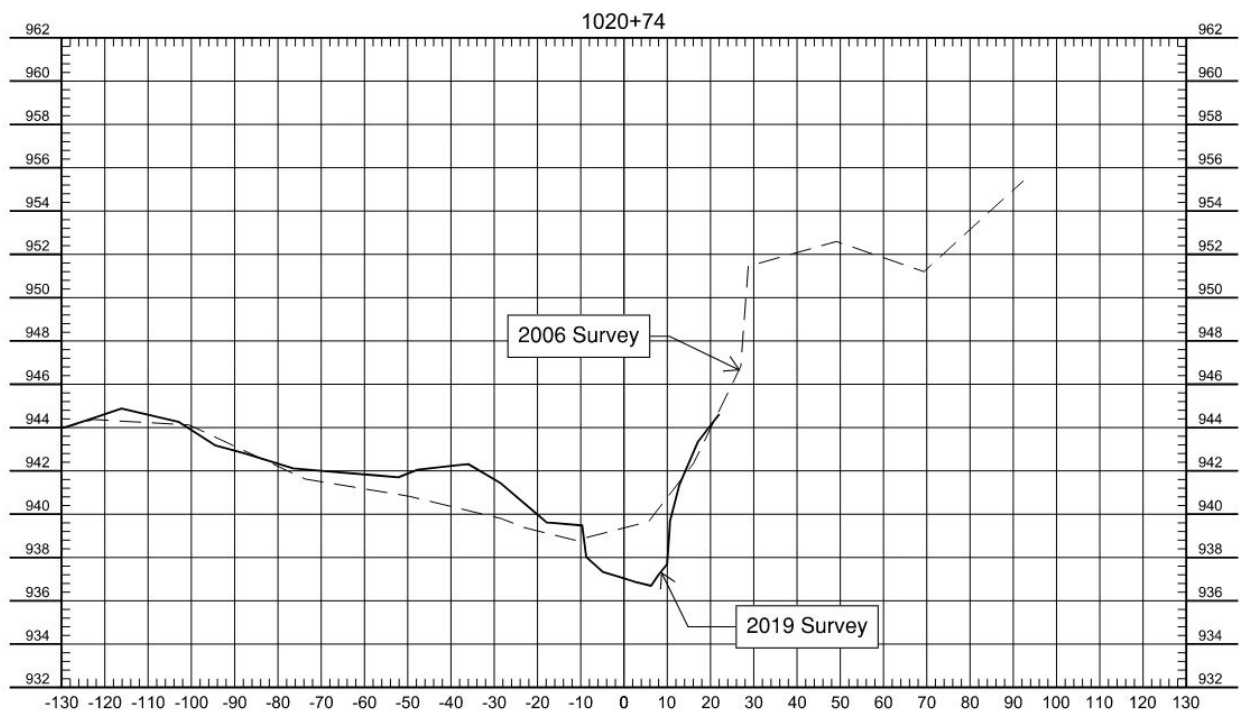
*Image 4 – Cross section survey comparison showing channel scour and deposition in the Beach Ridge*

Survey data and site observation indicate that the channel has incised significantly based on historic floodplain elevations. This incision has consequentially caused bank erosion in the Beach Ridge since the 2006 survey was collected. Based on comparison of the surveyed cross sections, there are several locations where the river has scoured the channel bottom on the outside of the bend and deposited the material on the inside bend. An example is shown in **Image 4**. Other surveyed cross sections show evidence of bank erosion as seen in **Image 5**. Bank erosion was also evident during the site visits as shown **Image 6**.

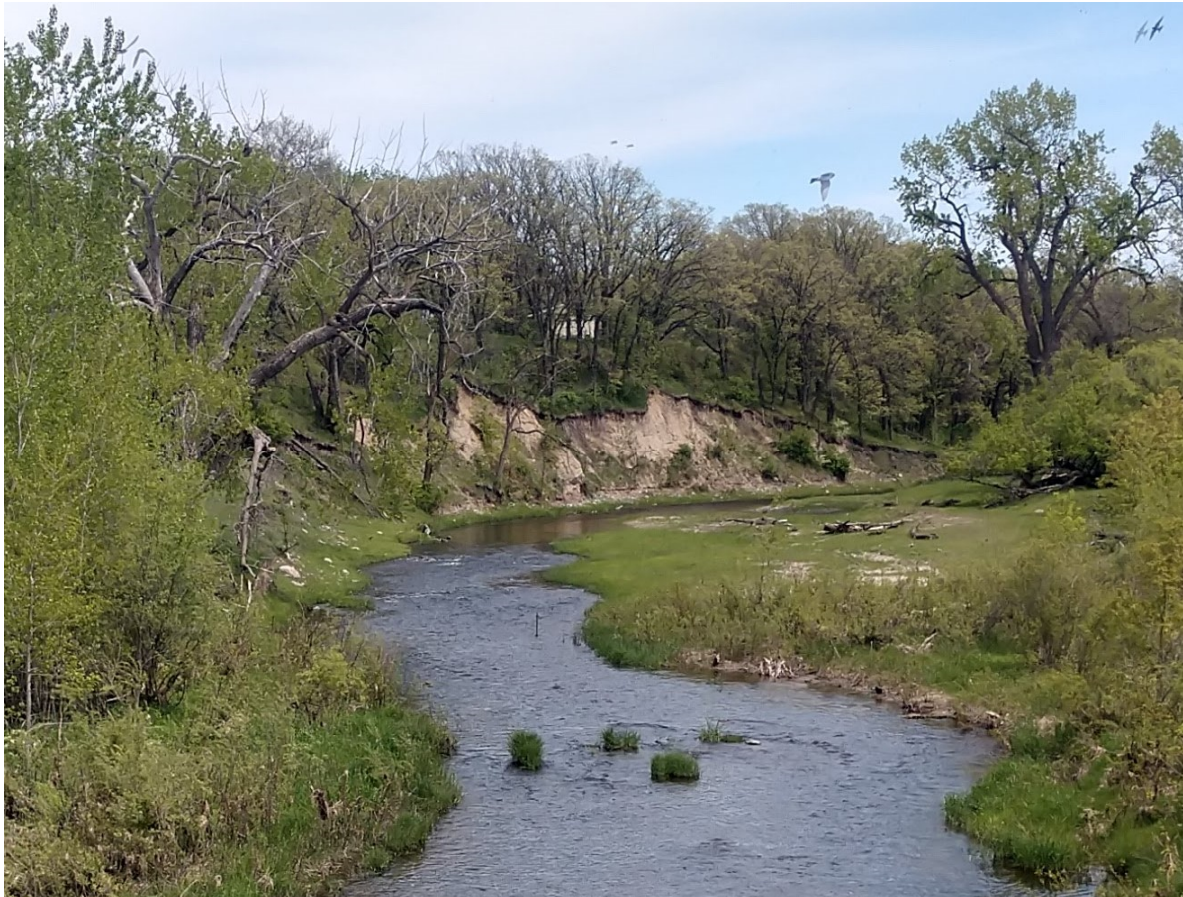
Image 6 – Photo in the Beach Ridge of unvegetated unstable bank

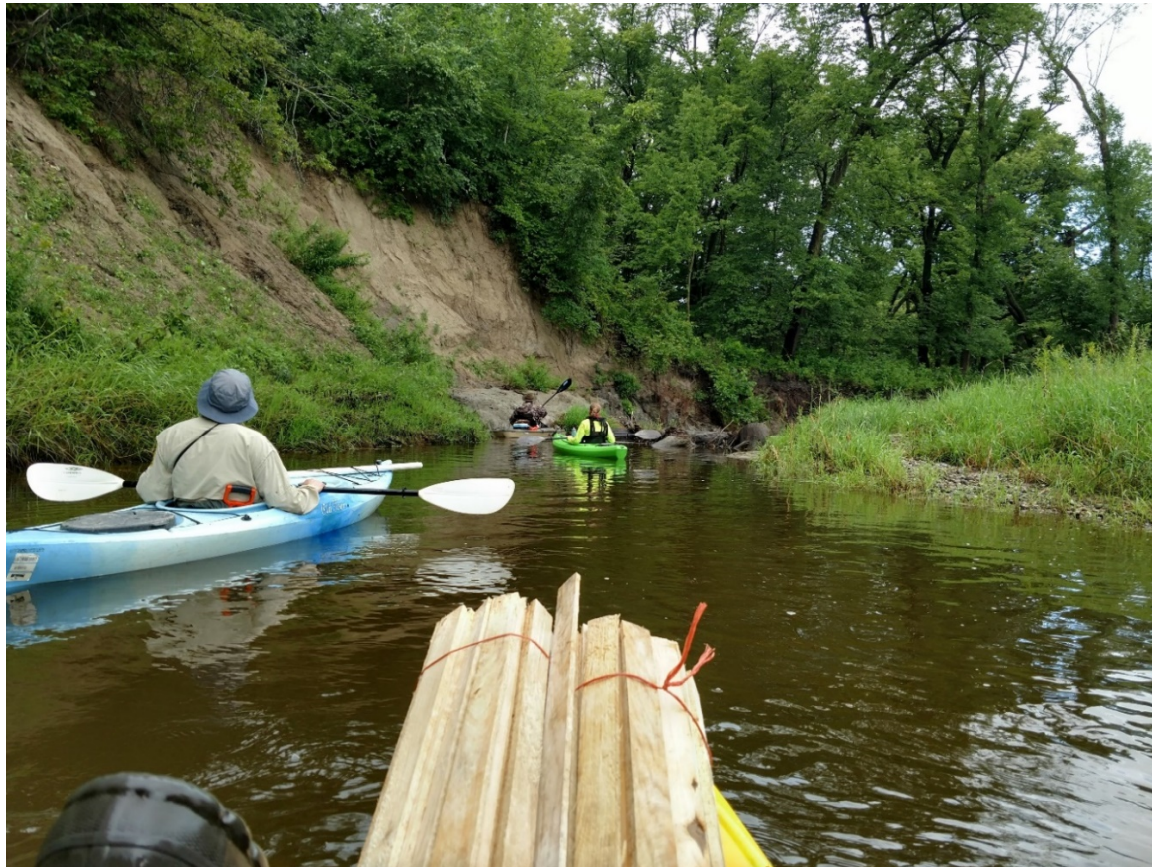
*Image 7 – Photo of the Reference Reach showing an unvegetated erosive bank*

Upon completion of site reconnaissance, the Reference Reach, which is contained in the Upper Ridge, was found to not be as stable as originally believed. Paddling the river in this reach revealed much of the system is entrenched and disconnected from its floodplain as shown in **Image 7**. The Reference Reach is experiencing some bank erosion as well, however the grade in this reach is significantly flatter than the Beach Ridge and so erosion is less severe. Aerial imagery review shows that several meanders in the Reference Reach have also been cut off during large flood events. A map of the cut off meanders is provided as **Exhibit 5**.

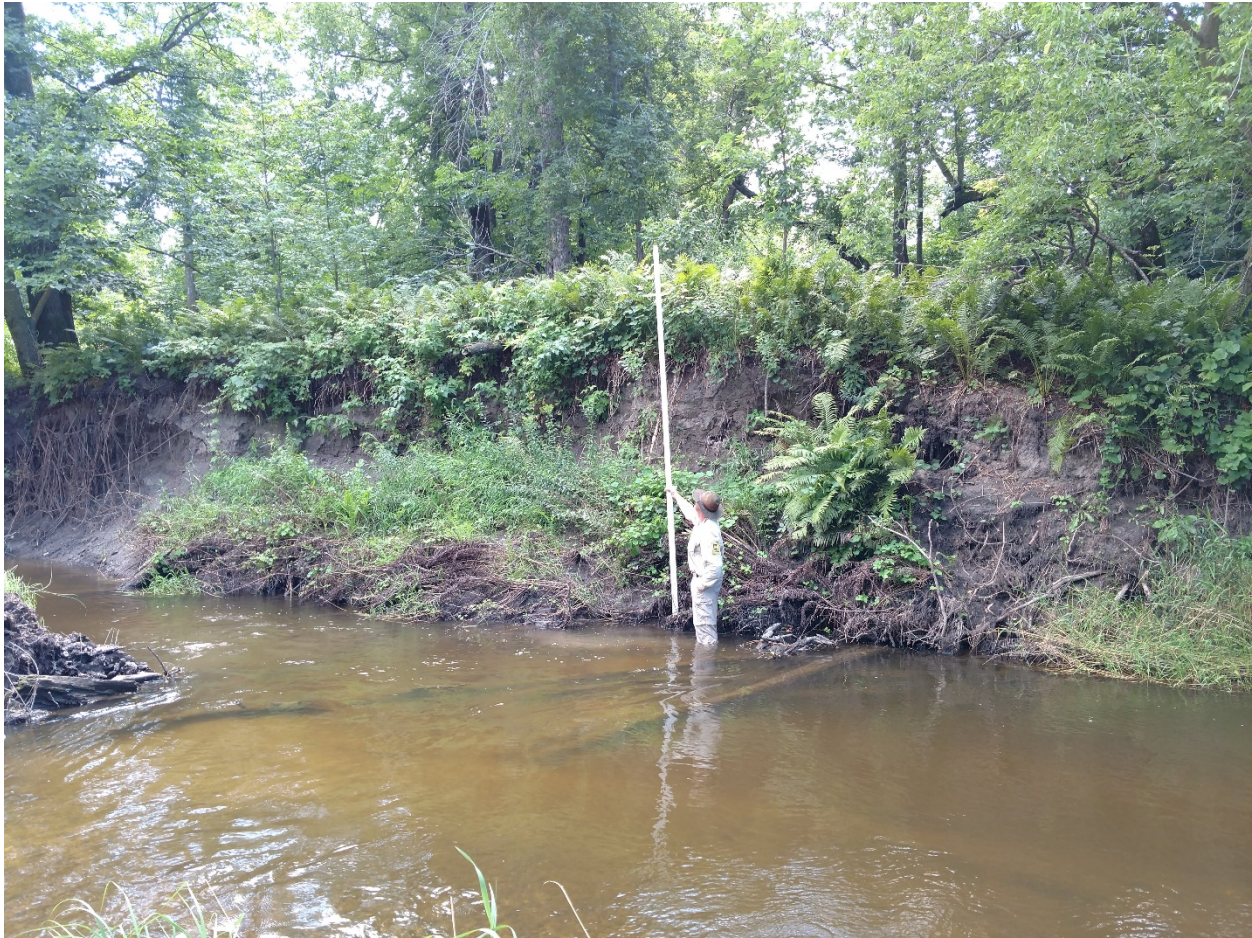
*Image 8 – Photo showing the disconnection of the river to its historic floodplain in Reference Reach*

Bankfull discharge was used to guide the stream classification. Details of the analysis and determination of bankfull discharge are provided in **Section 4.2**. Slopes in the Ridge Reaches range from 0.10% to 0.50%. Although both pool and riffle cross sections were surveyed, the riffle cross sections were used to determine bankfull dimensions as recommended by Rosgen. Width to depth ratios of the cross sections were consistently greater than 12, however, there were several cross sections with entrenchment ratios less than 1.4. The entrenchment ratio is the ratio of the flood-prone width to the bankfull channel width. The flood-prone width is measured at the elevation that corresponds to twice the maximum depth of the channel at bankfull. A low entrenchment ratio is indicative of a river that is disconnected from its floodplain as shown in **Image 8**.

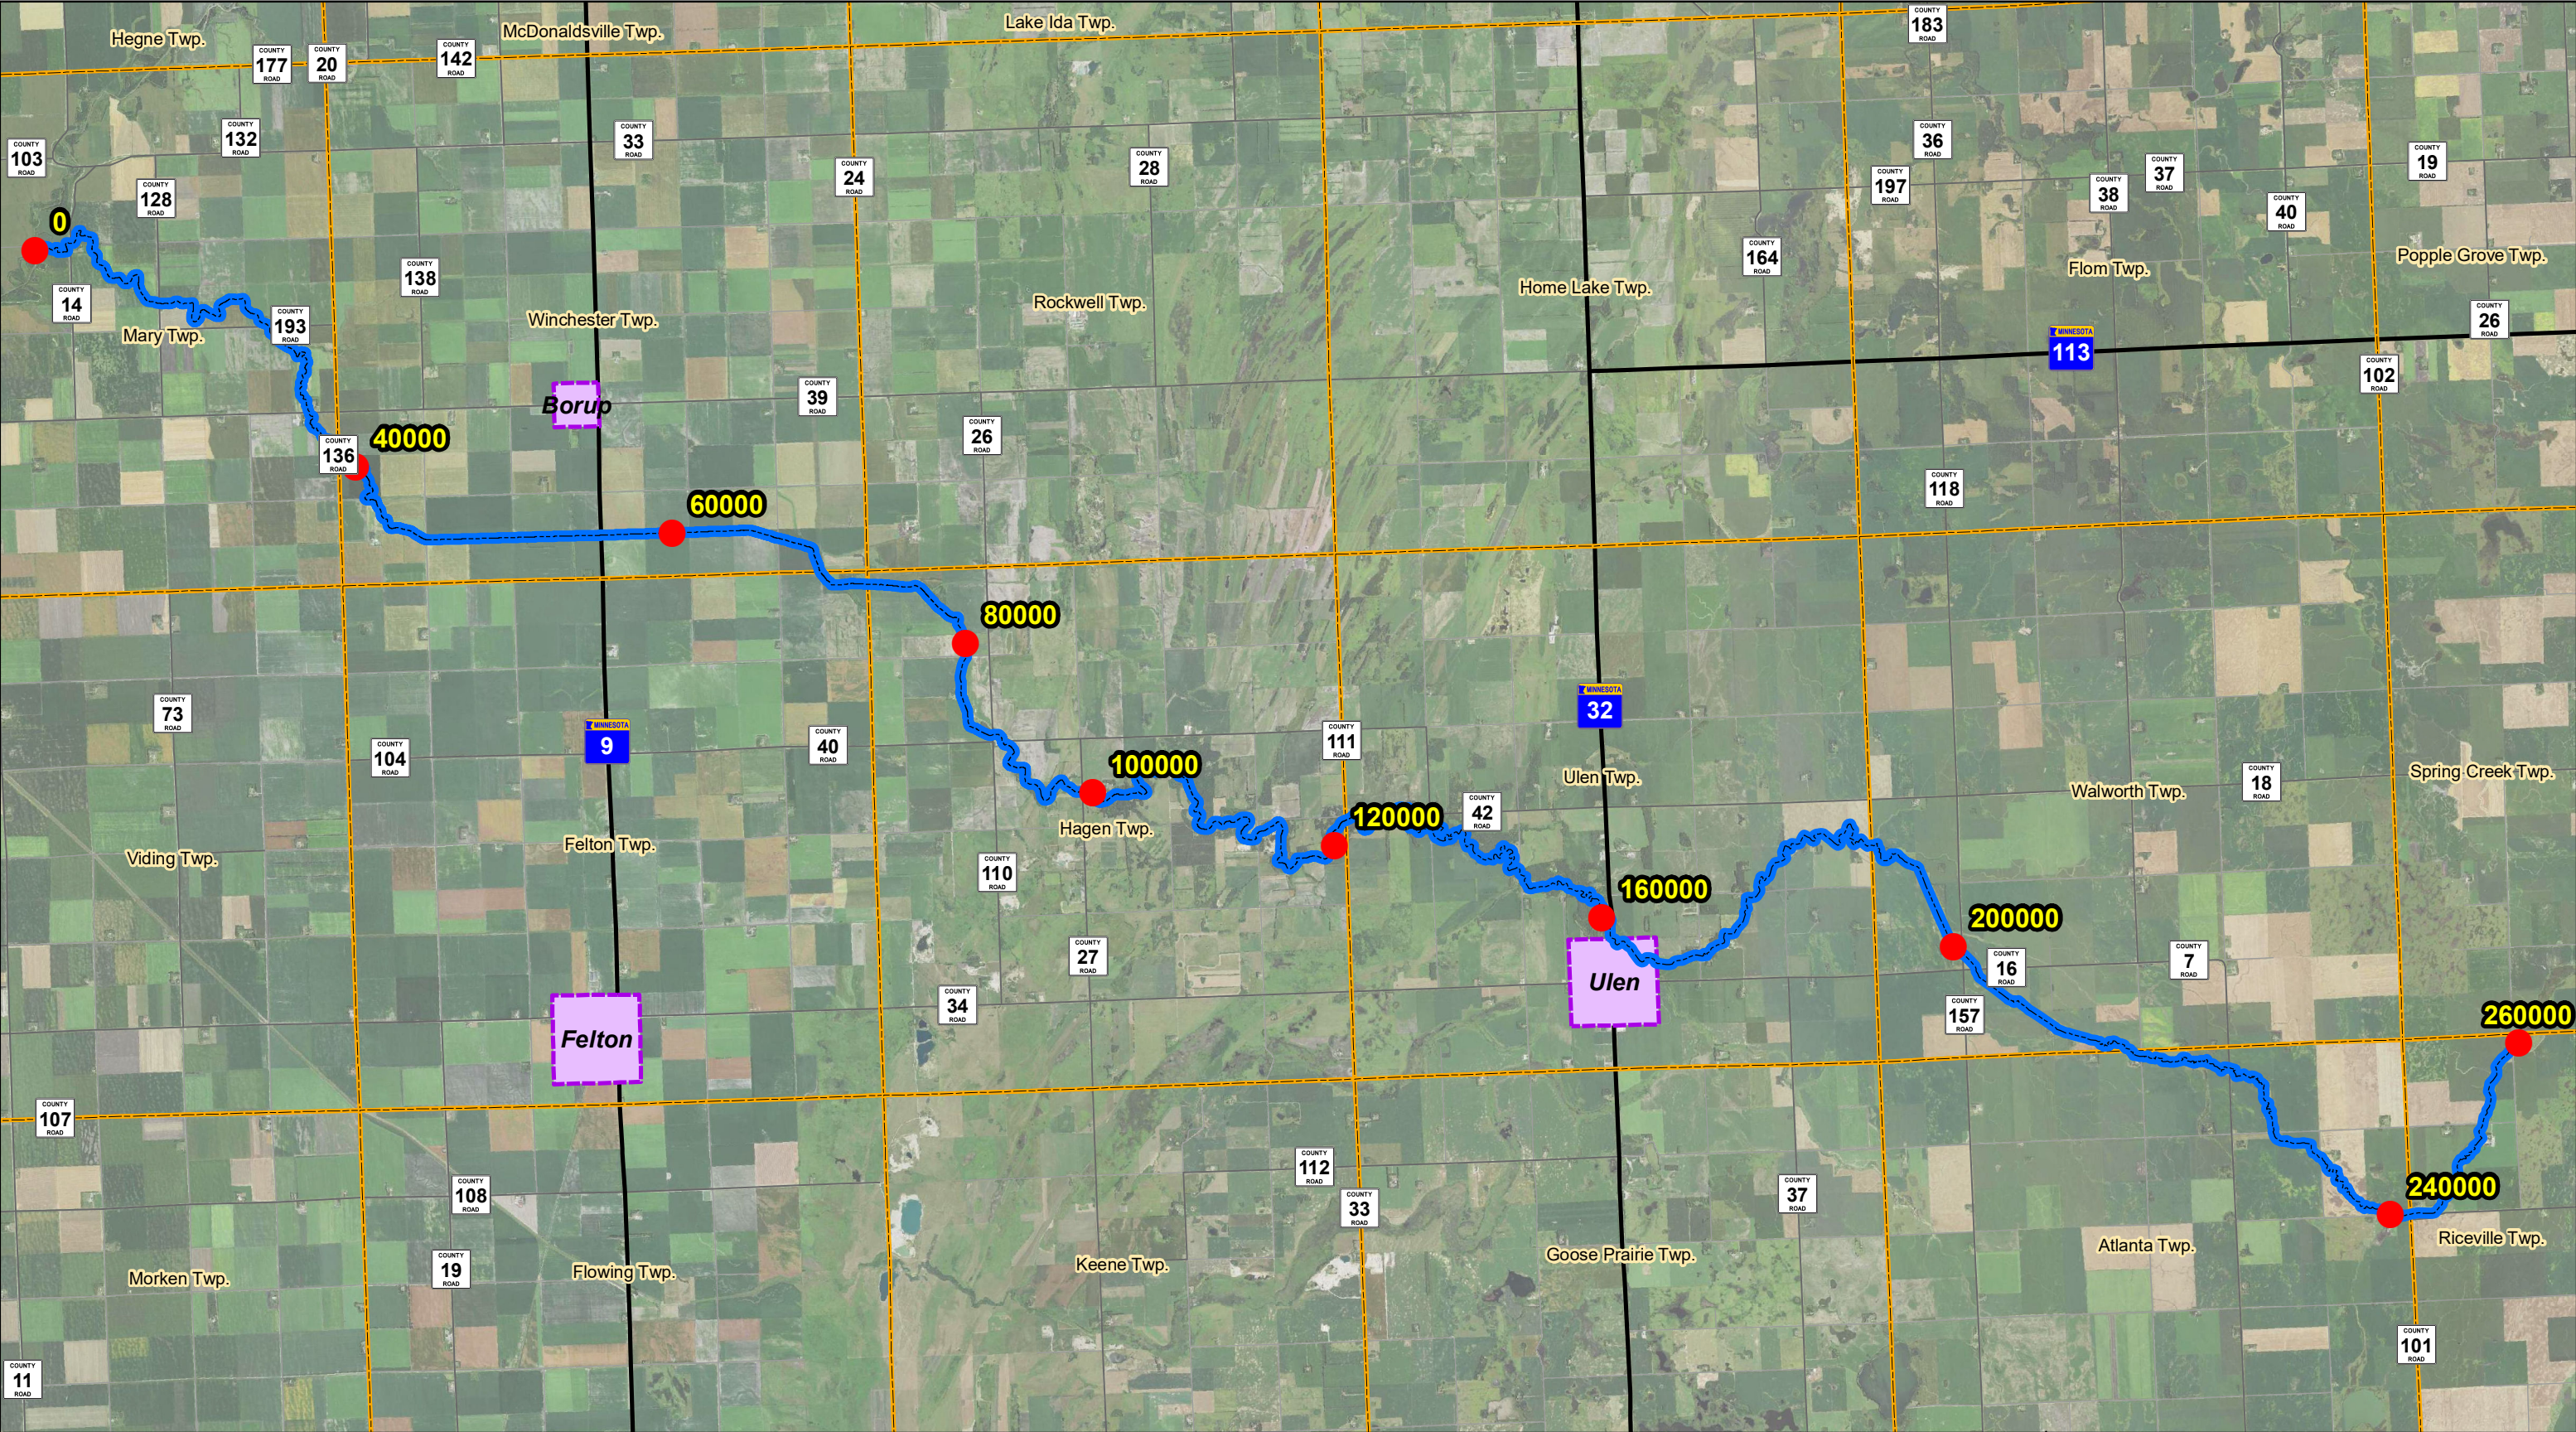
**Exhibit 1: Plan View**

The only available survey data through the beach ridge itself originated in 2006, with limited channel survey near culverts in 2017 as part of the RCPP efforts (**Exhibit 3**). Additional survey would be required through this reach to validate the magnitude of channel profile change.

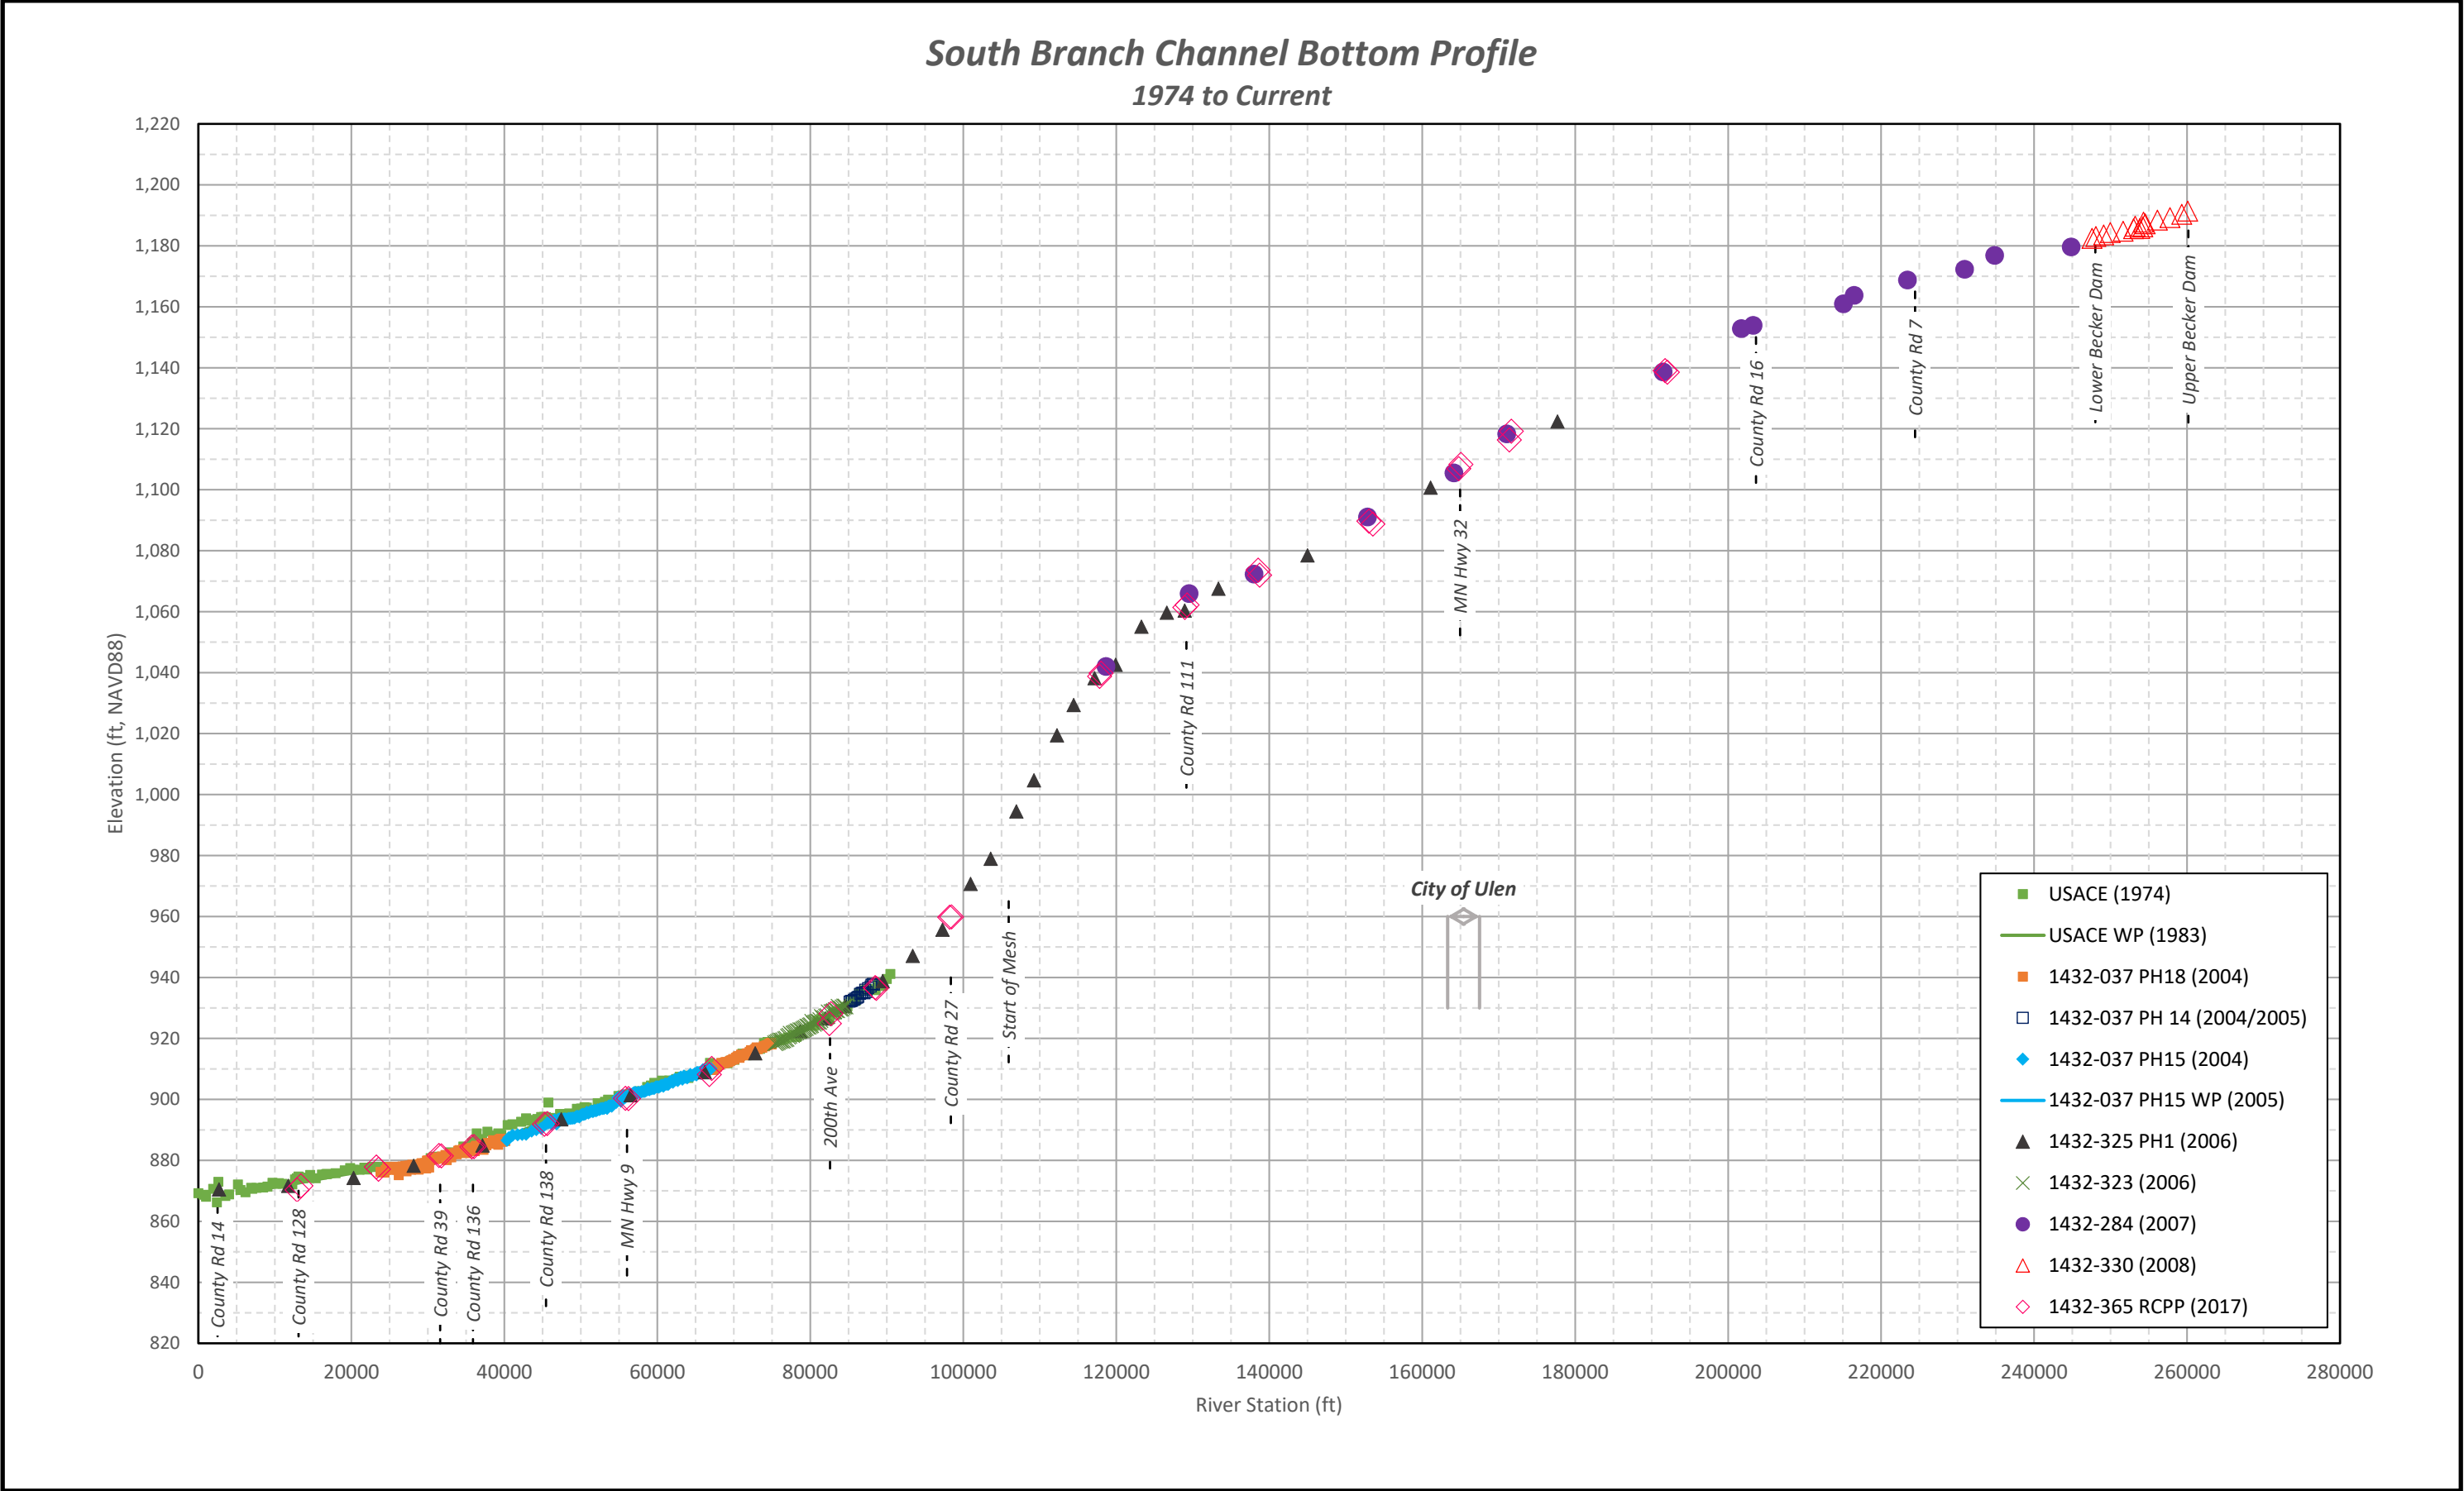
Exhibit 2: Profile Plots

# South Branch Channel Bottom Profile 1974 to Current

Numerous previously obtained survey files were compiled for this evaluation to identify if erosion and sedimentation locations can be understood. The majority of the historical survey exists downstream of the beach ridge from the 1983 USACE design, subsequent studies and construction projects. As compared to the 1983 design, much of the recent survey elevations downstream of Highway 9 appear to show erosion, degradation (channel lowering). Through the constructed channel upstream of Highway 9, slight aggradation is appearing (channel bottom increasing).

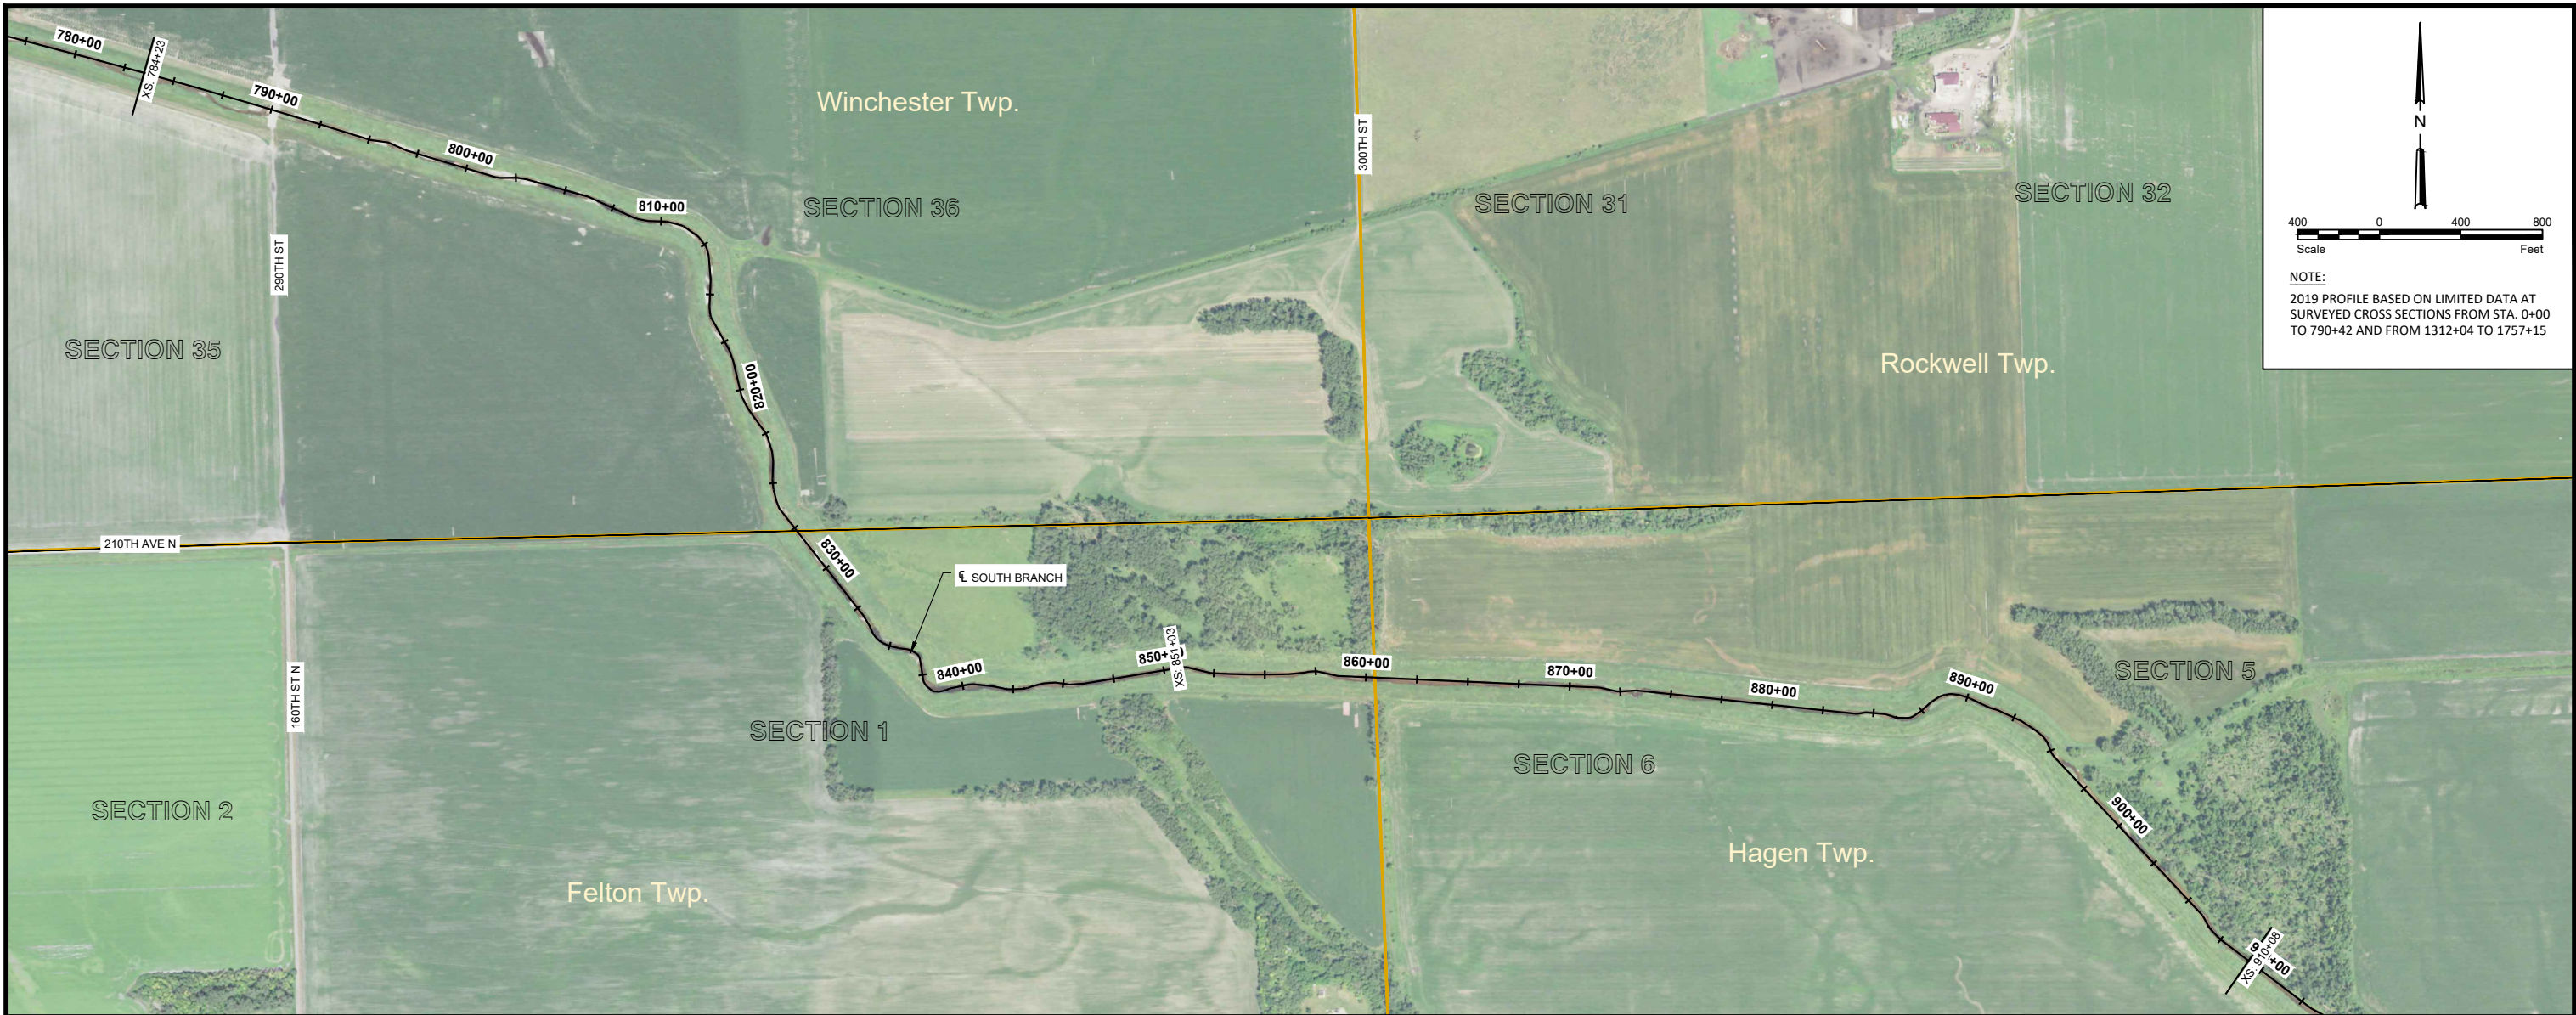
NOTE:  
2019 PROFILE BASED ON LIMITED DATA AT  
SURVEYED CROSS SECTIONS FROM STA. 0+00  
TO 790+42 AND FROM 1312+04 TO 1757+15

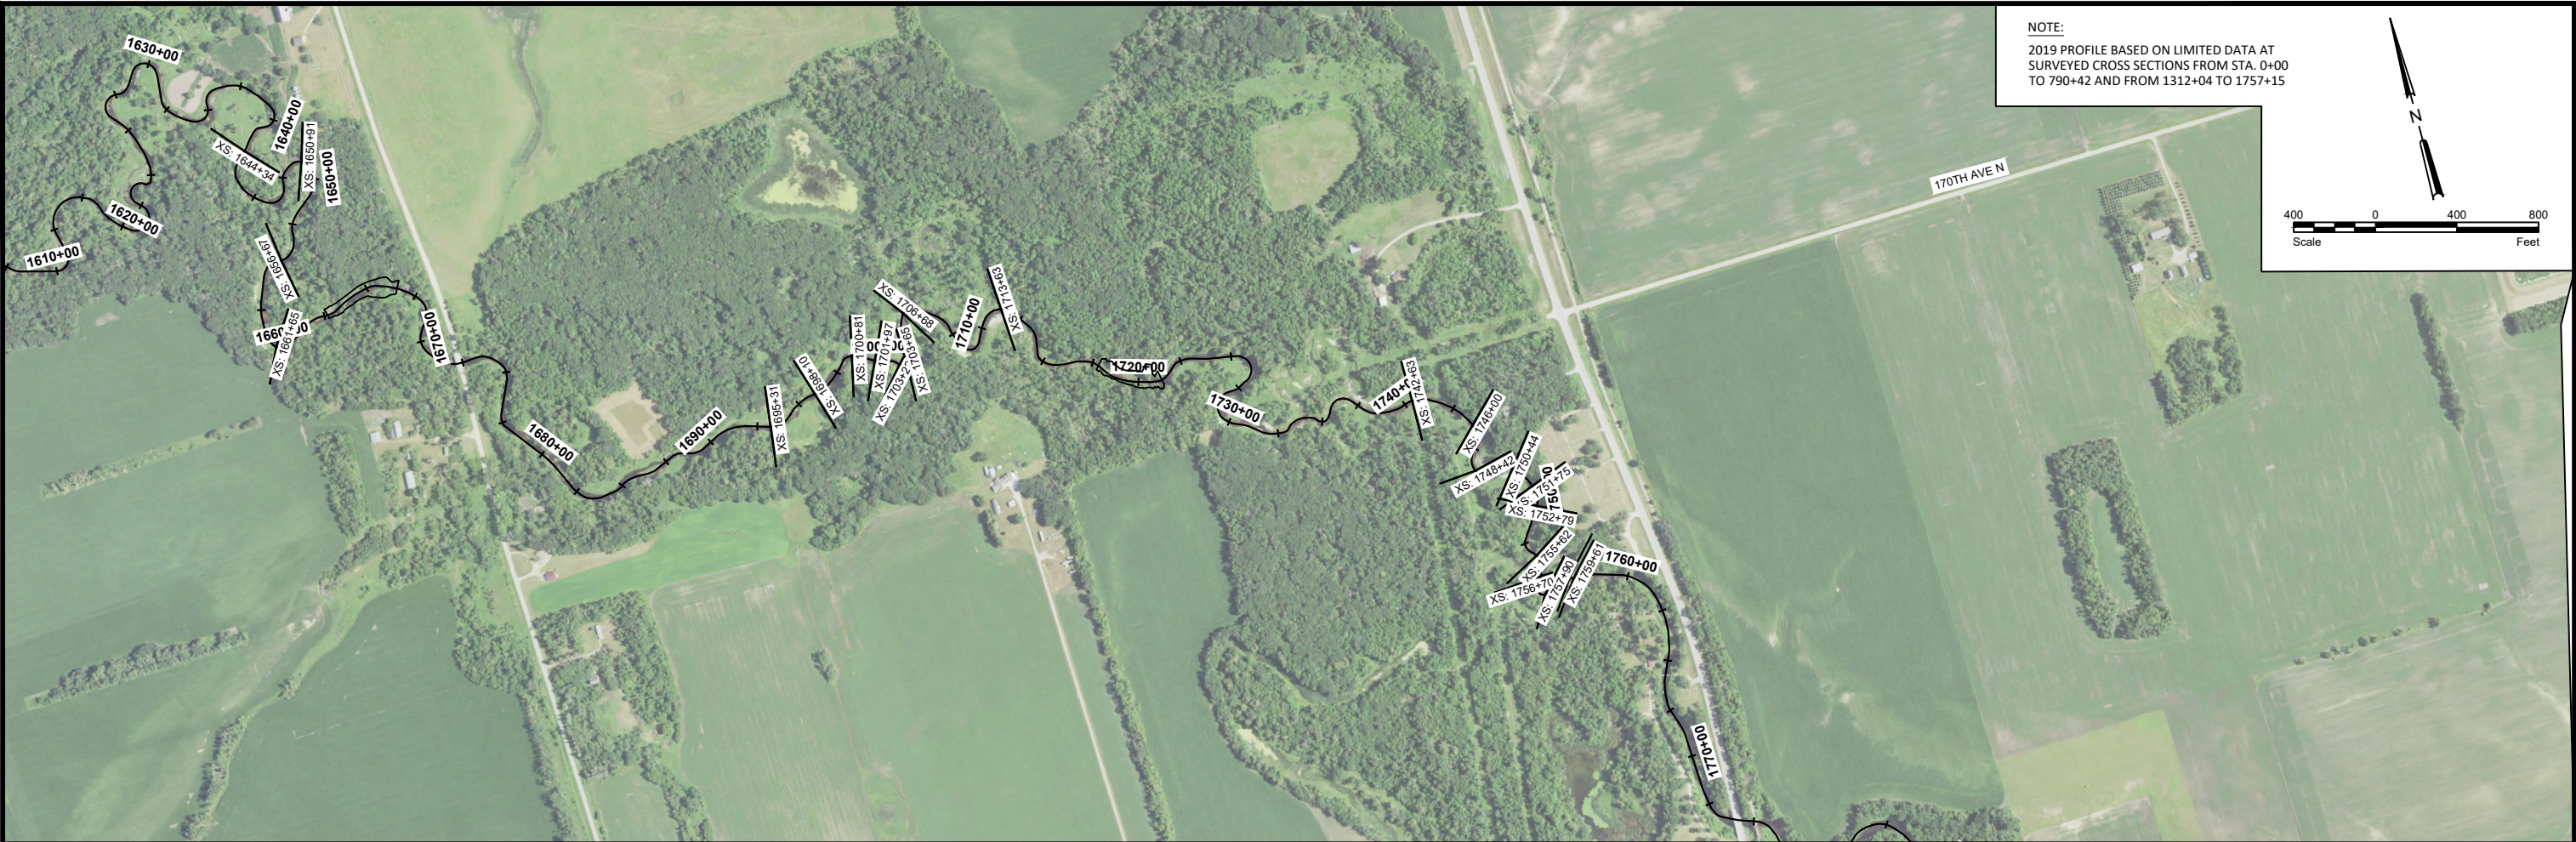
NOTE:  
2019 PROFILE BASED ON LIMITED DATA AT  
SURVEYED CROSS SECTIONS FROM STA. 0+00  
TO 790+42 AND FROM 1312+04 TO 1757+15

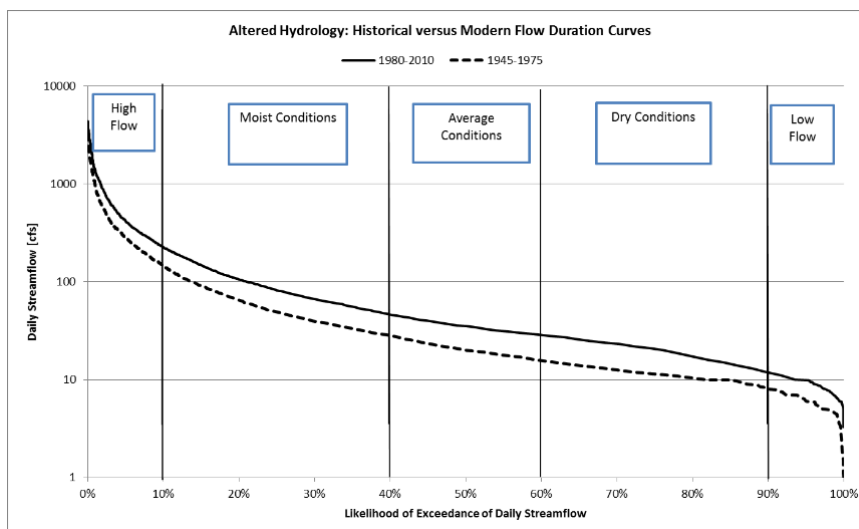
**Figure 1.** Flow duration curve for the Sand Hill River at Climax, Minnesota. The solid black line shows an increase in daily mean discharge for the 1980 – 2010 period, compared to the early 1945 – 1975 period.

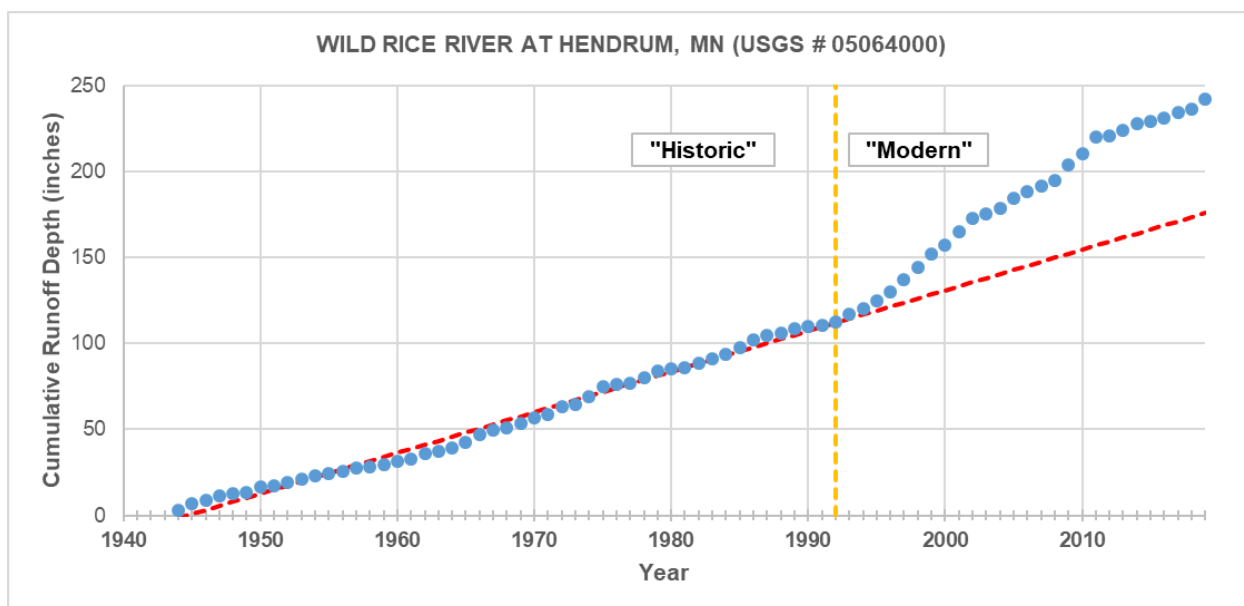
To illustrate an example of a change in streamflow and the validity in the breakpoint period, cumulative streamflow (using annual depth values) is plotted across time (**Figure 2**) for the USGS gage at the Wild Rice River at Hendrum, MN (USGS Station 05064000). Cumulative streamflow was used instead of straight annual streamflow because (1) it linearizes streamflow relationship where the slope of a trendline would be the average annual streamflow, (2) no assumptions about multi-year dependencies (e.g. changes in storage) or autocorrelation is necessary, and (3) changes in slope can be visualized, showing an altered state of hydrology.

Figure 2. Cumulative streamflow for the Wild Rice River at Hendrum, MN (USGS Station 05064000).

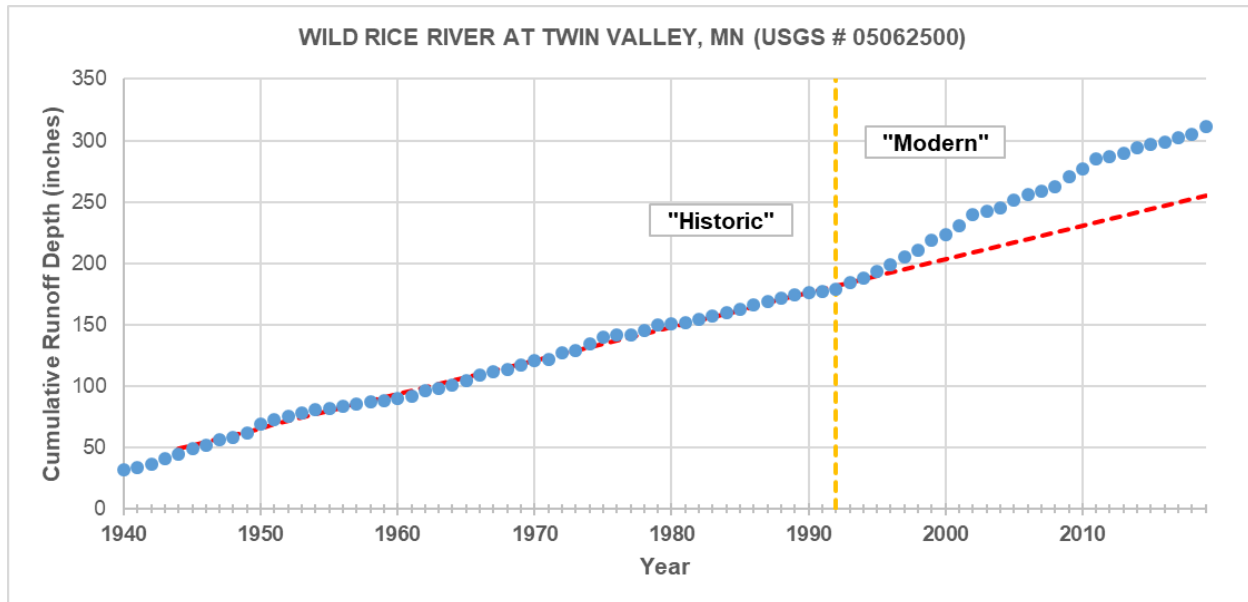
**Figure 3** shows the cumulative streamflow (in inches per year) for the gaging site. Cumulative streamflow is used to determine a breakpoint between the benchmark condition and the altered condition (see **Section 2.3**).

Figure 3. Cumulative streamflow for the Wild Rice River at Twin Valley, MN (USGS Station 05062500).

According to the cumulative streamflow analysis, a breakpoint exists around 1992. Therefore, the benchmark “historic” conditions include data from 1967 through 1991 and the altered “modern” conditions include data from 1992 through 2018. This results in a comparison period of 26 years.

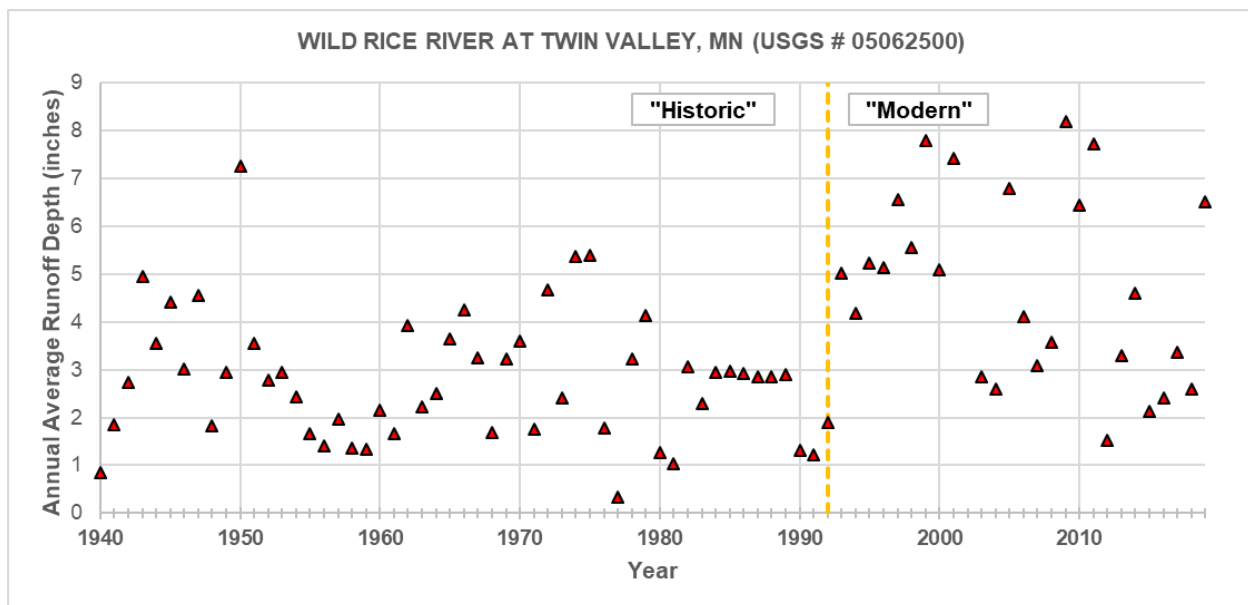
Additionally, the runoff (using non-cumulative annual depth values) is plotted in Figure 4.

Figure 4. Average annual runoff depth for the Wild Rice River at Twin Valley, MN (USGS Station 05062500).
