# FEASIBILITY STUDY REPORT

## South Branch Wild Rice River Restoration & Sediment Reduction

Wild Rice  
Watershed  
District

May 6, 2020

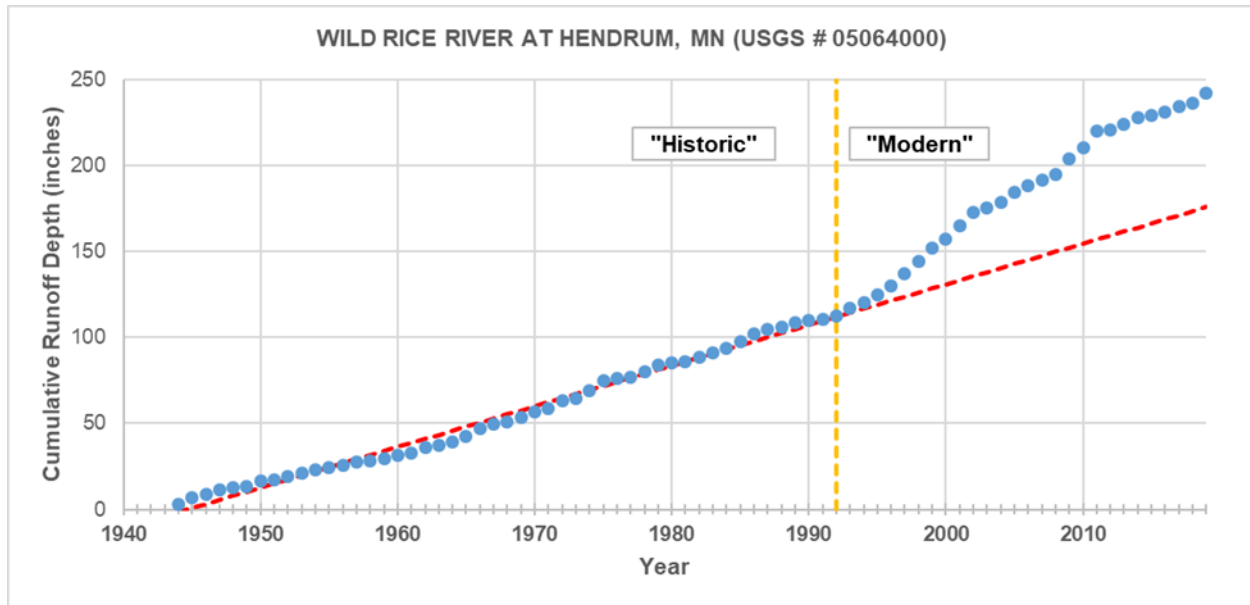
**Figure 5** shows the cumulative streamflow (in inches per year) for the gaging site. Cumulative streamflow is used to determine a breakpoint between the benchmark condition and the altered condition (see **Section 2.3**).

Figure 5. Cumulative streamflow for the Wild Rice River at Hendrum, MN (USGS# 05064000).

According to the cumulative streamflow analysis, a breakpoint exists around 1992. Therefore, the benchmark “historic” conditions include data from 1967 through 1991 and the altered “modern” conditions include data from 1992 through 2018. This results in a comparison period of 26 years.

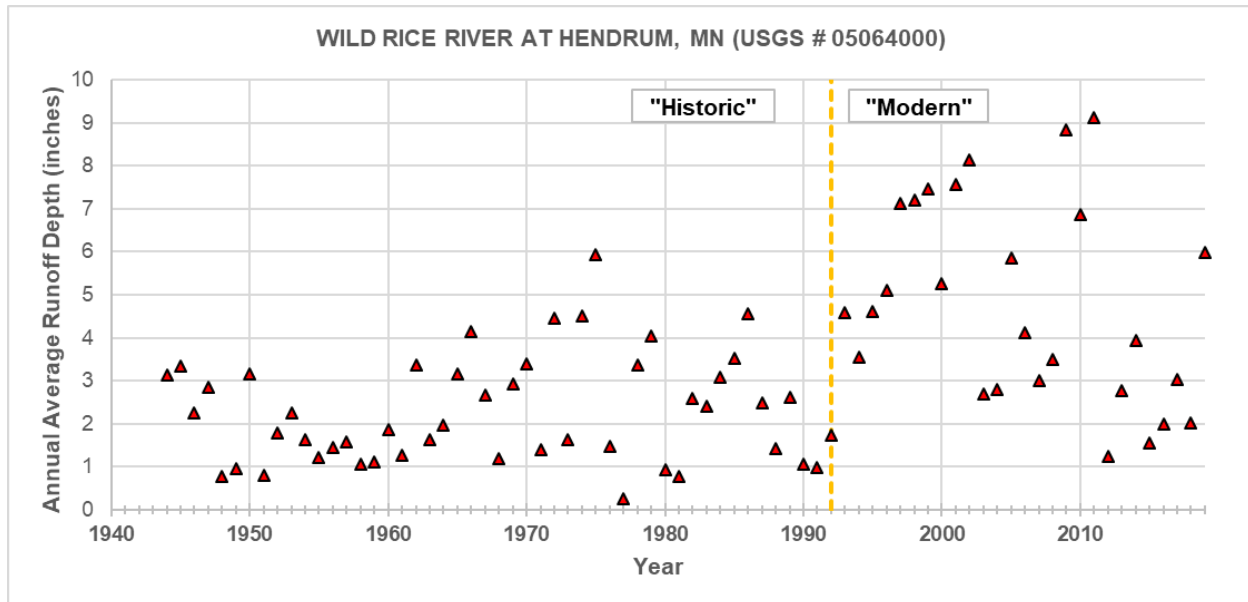
Figure 6. Average annual runoff depth for the Wild Rice River at Hendrum, MN (USGS Station 05064000).
